AstraTech  
Implant System<sup>®</sup>

## CASE REPORT

Digital assisted precise  
planning and manufacturing  
of a fixed dental restoration

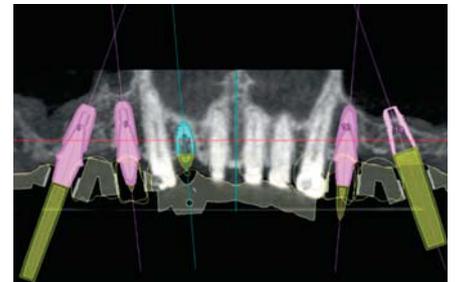
**3.** Simplant software for planning the implant positions.

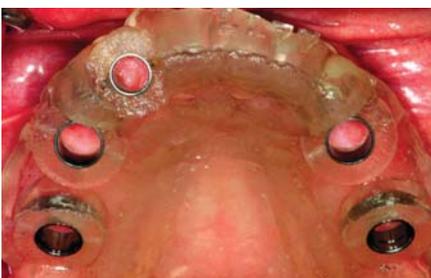
**4.** Simplant Guide for the first drilling steps.

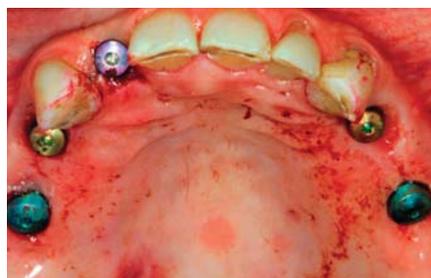
**5.** Color-coded HealDesign EV in place.

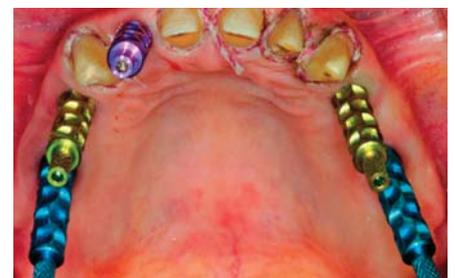
**6.** Implant Pick-Ups EV in position.

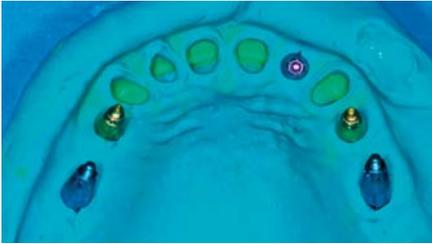
**7.** After impression taking, the interfaces of the impression posts were revealed in the impression.

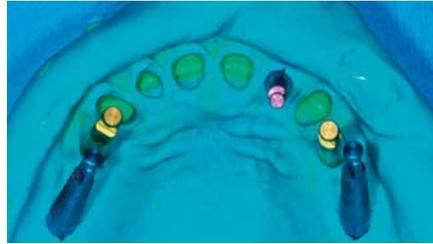
**8.** Color-coded Implant Replicas EV are assembled to the Implant Pick-Ups EV in the impression.

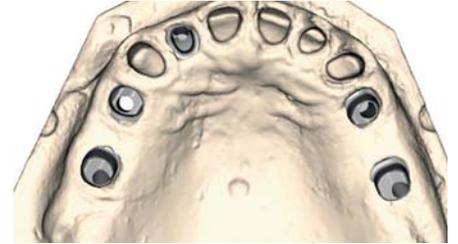
**9.** Online Atlantis WebOrder showing the Atlantis patient-specific abutments with a digital wax-up transparent overlay.

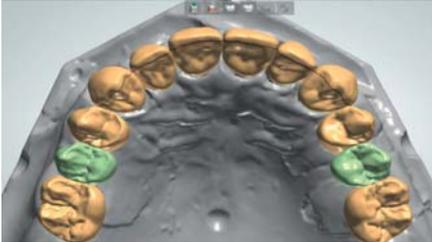
**10.** Occlusal view of the fullcontour digital wax-up prior to digital cutback.

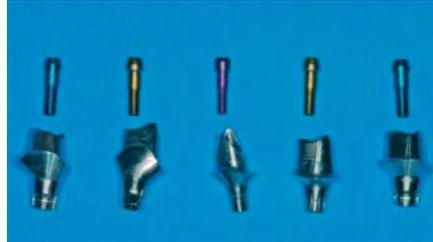
**11.** Atlantis patient-specific abutments with corresponding screws.

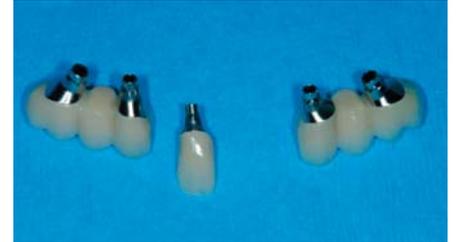
**12.** Full-contour CAD/CAM PMMA provisional restorations.

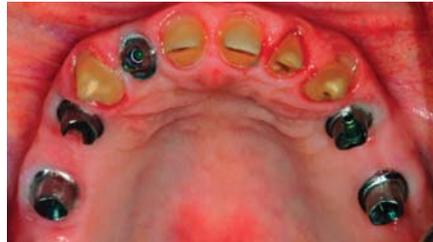
**14.** Atlantis patient-specific abutments installed.

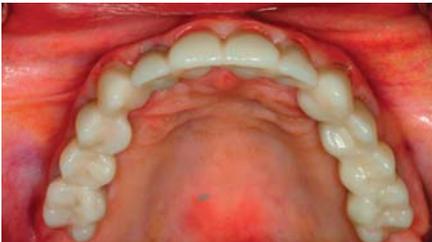
**16.** The maxillary arch restoration with occlusal and interproximal zirconia.

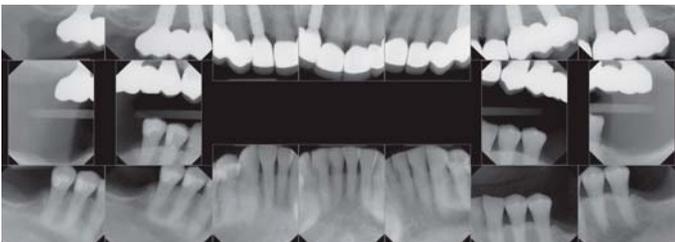
**19.** Radiographs of implants in the molar, premolar and lateral positions, along with the remaining natural dentition.

Extraction of the hopeless teeth and socket preservation grafting were performed. Five OsseoSpeed EV implants were placed; the two in the molar region were angled by 30 degrees. Afterwards a restoration with high-strength zirconia framework and a precise cutback for the veneering porcelain was digitally designed and fabricated. The patient was very satisfied with the fit and esthetic outcome of the bridge.
