AstraTech
Implant System®

CASE REPORT

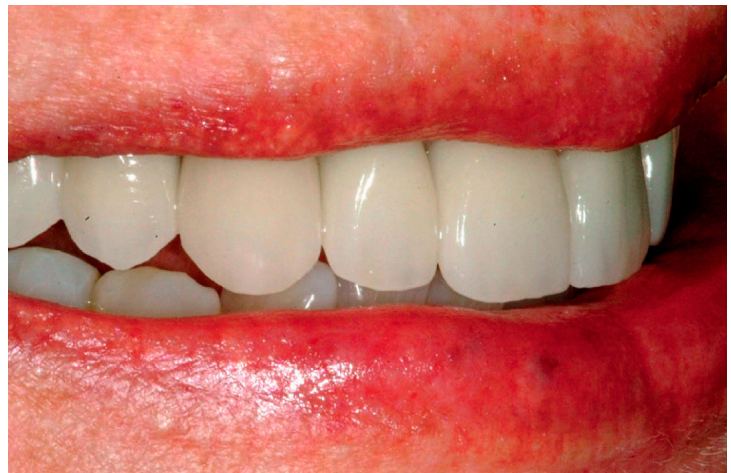
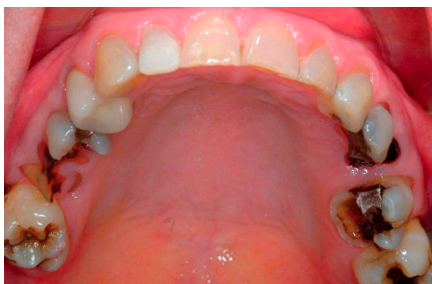
1. Pre-treatment clinical situation.

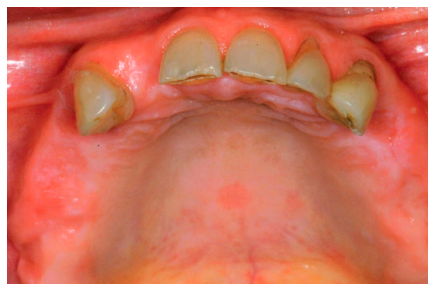
2. Intraoral condition three months after extraction and grafting.

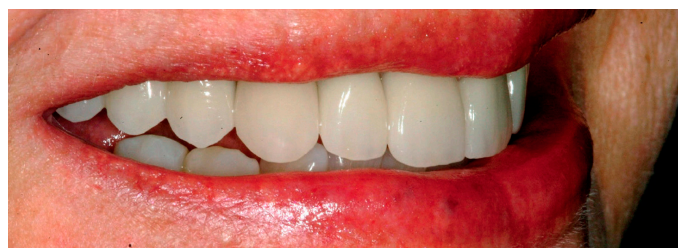
20. The patient's smile following maxillary arch reconstruction of her remaining natural teeth and implants.
