Dr Anthony Bendkowski
Oral Surgeon
Private Practice
Maidstone, Kent UK

Screw-retained restoration of upper right first molar and second premolar supported by the DS OmniTaper Implant System

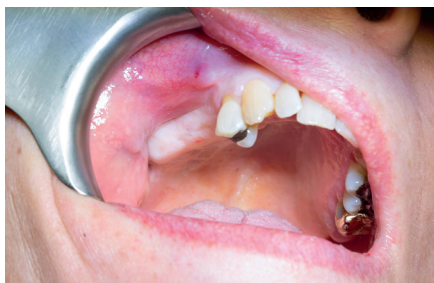
1. The failing upper right second premolar and first molar were extracted by the patient's general dental practitioner prior to the planned implant treatment.

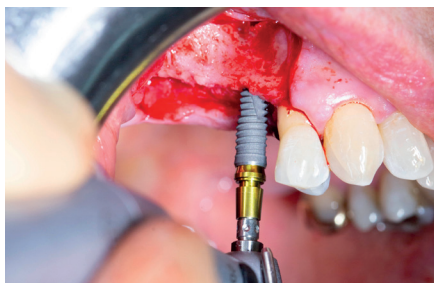
4. Installation of an OmniTaper EV Ø3.8 x 11 mm implant in tooth #4 (FDI 15) position using the TempBase Driver.

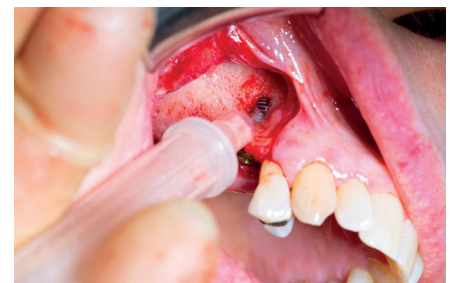
6. Use of Dentsply Sirona disposable BoneTrap to augment the small bone fenestration.

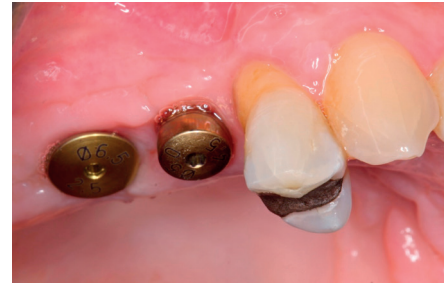
12. Healing Abutment EV (M) placed at 3 months after initial surgery.

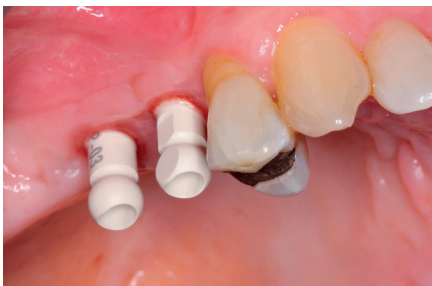
13. Atlantis IO FLO in situ ready for Primescan digital impression.

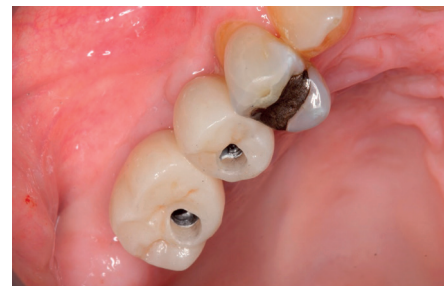
15. Well fitting screw-retained Atlantis CustomBase abutments and zirconia crowns tried in - no adjustments needed.

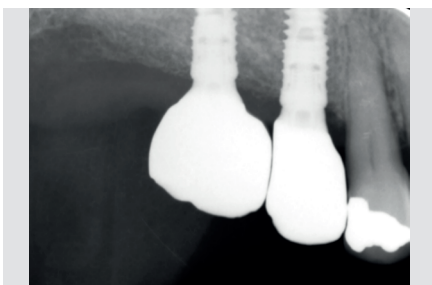
16. Radiograph to verify correct seating of restorations.

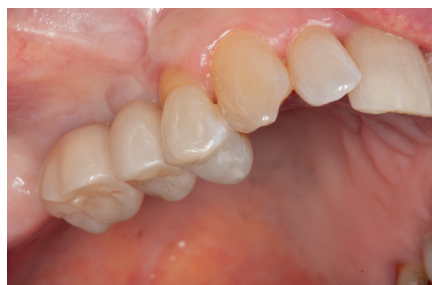
17. Screw-access channels sealed and amalgam tooth position #5 (FDI 14) replaced with composite.

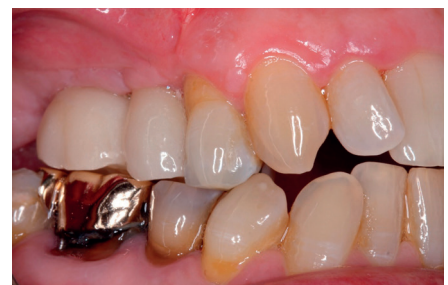
18. Final restorations completed.
