Illusion of nature

Non invasive esthetic rehabilitation. Bleaching in combination with single tooth implant restoration using the Atlantis Abutment in zirconia creates harmony and high esthetics.

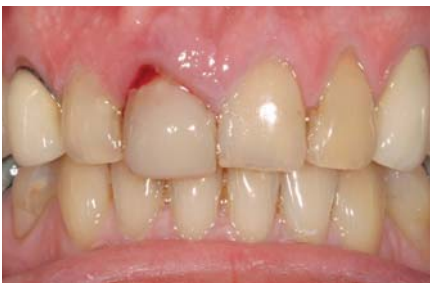
1. Acute consultation, 11 is mobile and tender.

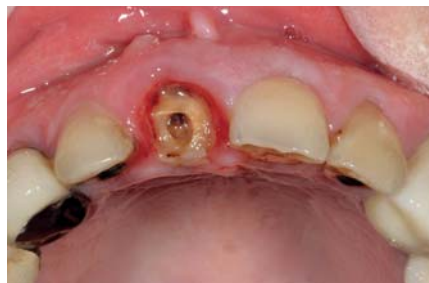
2. Clinical inspection reveals combined horizontal and vertical root fracture.

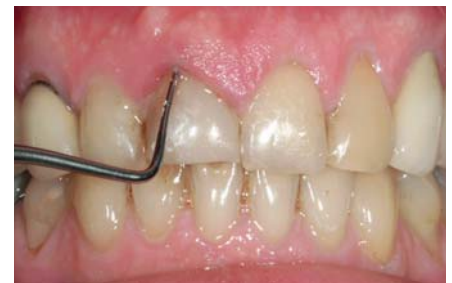
3. Provisional restoration. A combined horizontal and vertical root fracture has caused bone destruction buccally and there is pus upon probing. 11 is untreatable and will be extracted orthodontically.

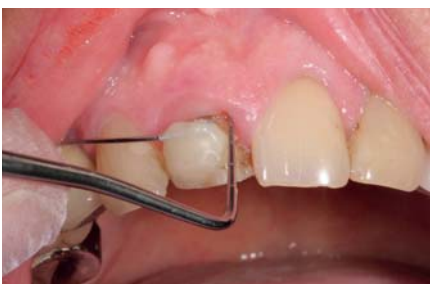
4. After almost 3 months of extrusion excess hard and soft tissues are evident buccally and also good conditions for extraction and immediate installation of an implant.

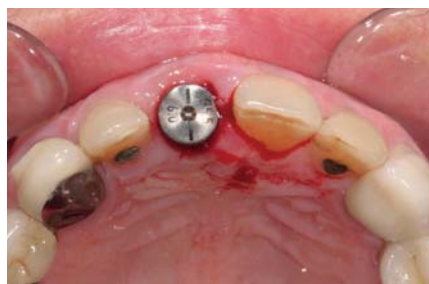
5. Implant is installed and a healing abutment is placed.

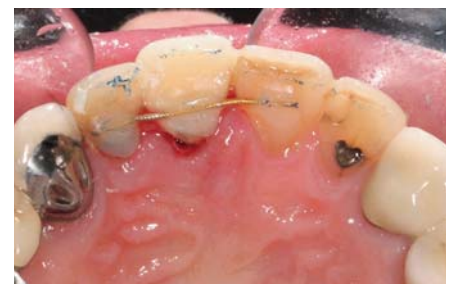
6. The patient is provided with a bonded temporary restoration.

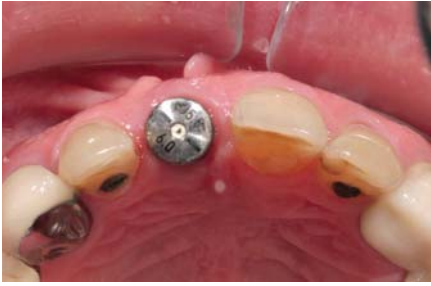
7. Four months after implant installation. The implant shows good stability and healed soft tissues.

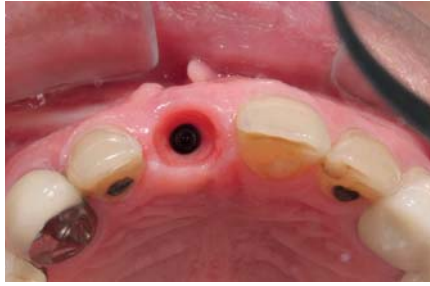
8. The healing abutment has created nice soft tissues which will be conditioned with a temporary construction in order to create an emergence profile.

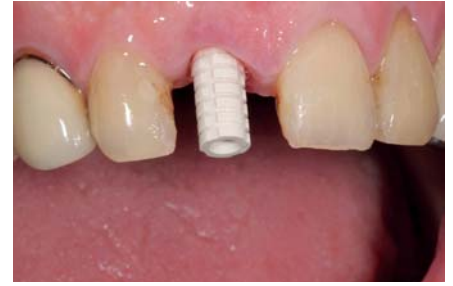
9. Temporary abutment in place before cutting it into a proper length. An acrylic crown form will be used together with cold cure acrylic.

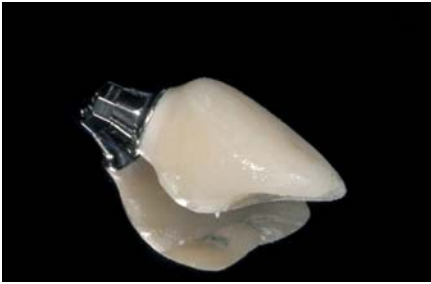
10. The finished temporary crown ready for insertion.

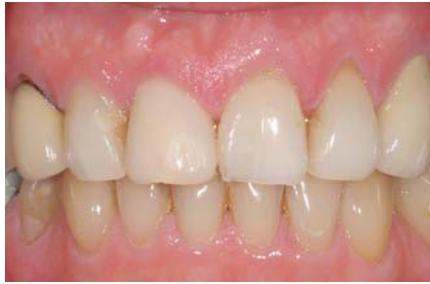
11. A few months later the gingival margin has stabilized and we are ready for finalization of the restoration. The other teeth have been bleached.

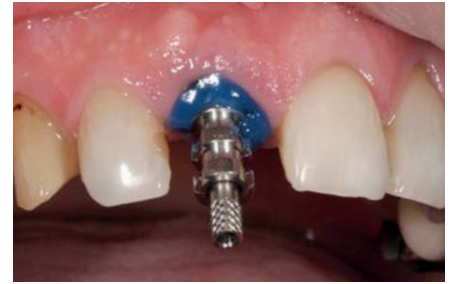
12. Impression is taken at implant-level and the created emergence profile is transferred to the model.

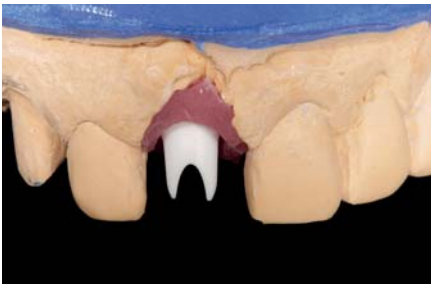
13. The model is scanned and an Atlantis Abutment in zirconia is produced and delivered to the technician.

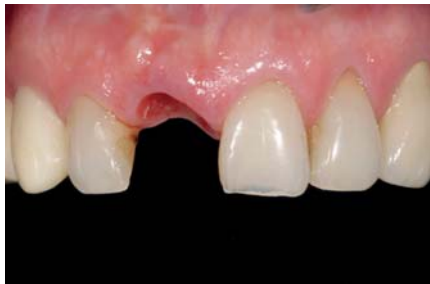
14. Ready for try-in of the Atlantis Abutment.

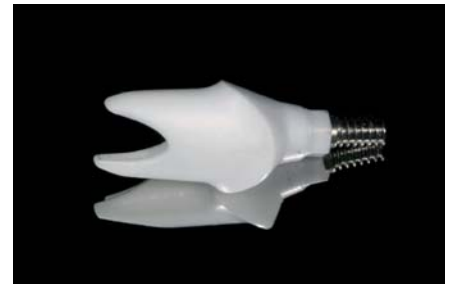
15. Atlantis Abutment in zirconia custom made for this specific case.

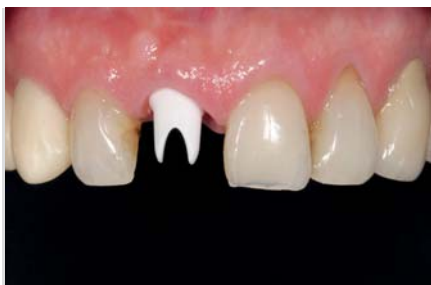
16. Try-in of final abutment.

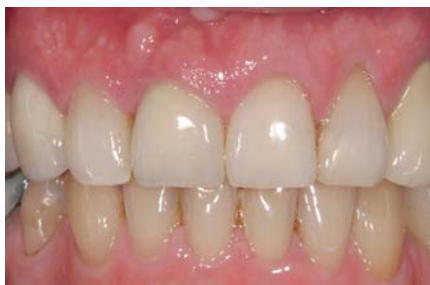
17. Finished treatment. An all ceramic crown is fabricated and cemented onto the Atlantis Abutment.

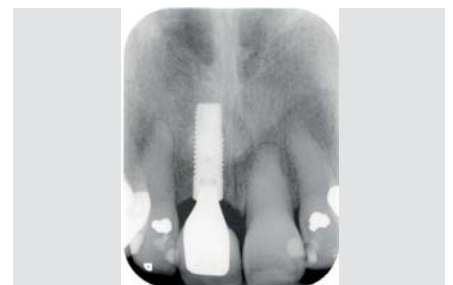
18. X-ray of the finished case.
